Technical Report ARPAD-TR-93004

AFIRS2 TEST EVALUATION

U.S. ARMY ARMAMENT RESEARCH, DEVELOPMENT AND ENGINEERING CENTER

Product Assurance and Test Directorate

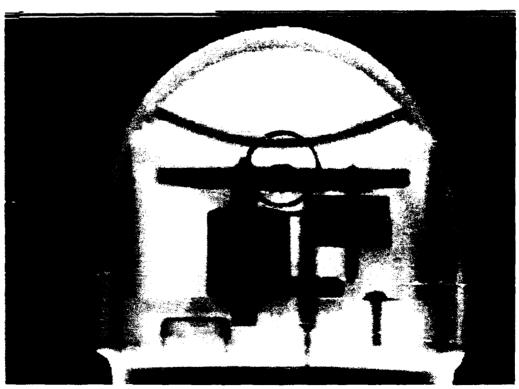
Figure 2. Fuze number 1532

Fuze number 1532, which has a short firing pin is shown in figure 2. This was missed by the x-ray film inspectors. This is an example of the AFIRS detecting defects that are extremely hard to see.

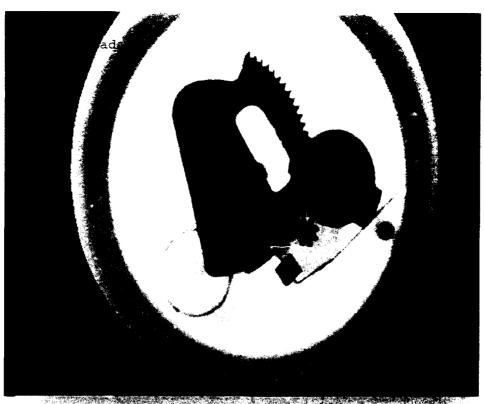
Figure 5. Fuze number 635

Fuze number 635 is shown in figure 5. This was rejected by AFIRS for the setback spring not being level. Looking at the image, one can see the spring is level, but it is touching the rotor gear assembly. This is a false reject. Fuzes such as this accounted for a majority of false rejects in this test run. An analysis of the setback spring area algorithms may be necessary.
